Manhole Inspection Summary

Manhole # S31E__032MH

Insp Date: **12/16/08 11:02 AM**

Location Address: **128 N Paca St**

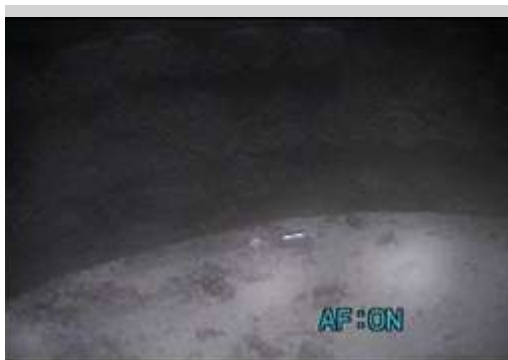
Miscellaneous

debris on bench

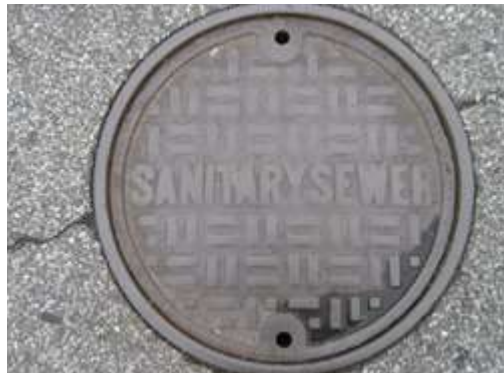
cover pic

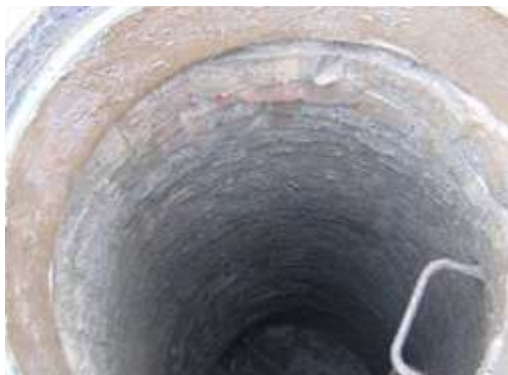
Defect 6

Offset: **1** (in.)

1 inch frame offset

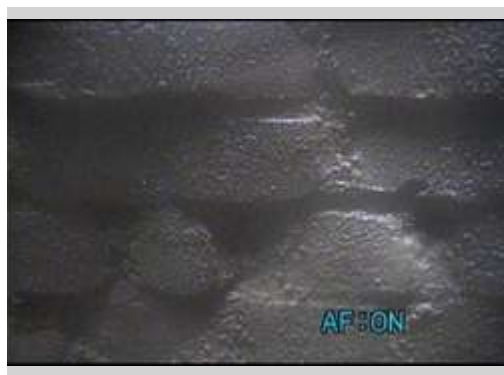
Defect 5

Condition: ☐ Sound ☒ **Cracked** ☐ Root Intrusion ☒ **Loose Brick** ☐ Deteriorated

cracked & loose bricks in corbel area

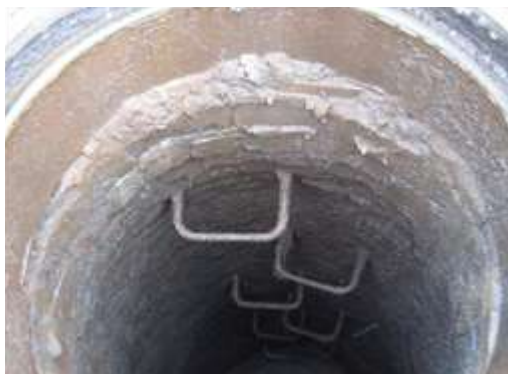
Defect 3

Condition: ☐ Sound ☐ Cracked ☒ **Leaks**

Condition: ☐ Sound ☐ Cracked ☐ Root Intrusion ☐ Loose Brick ☒ **Deteriorated**

Infiltration: ☐ None ☒ **Joint** ☐ Cracks ☐ Mortar ☐ Roots ☐ Wall

chimney deteriorated, infiltration lid/frame and chimney joint

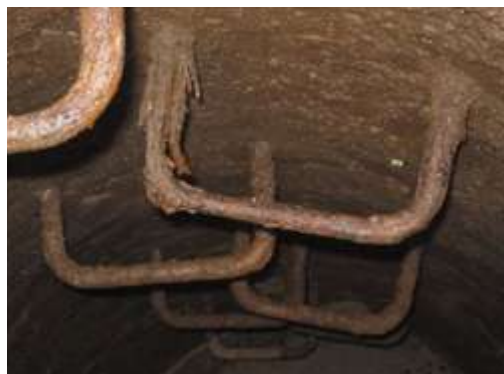
Defect 4

Count: **7** Missing: **1** ☒ **Corroded**

corroded rung
